Ice/Frost/Debris Assessment For Space Shuttle Mission STS-27R

(NASA-TM-102144) ICE/FROST/DEBRIS
ASSESSMENT FOR SPACE SHUTTLE MISSION
STS-27R, DECEMBER 2, 1988 (NASA) 200 p
CSCI 22B

ICE/FROST/DEBRIS ASSESSMENT
FOR
SPACE SHUTTLE MISSION
STS-27R
DECEMBER 2, 1988

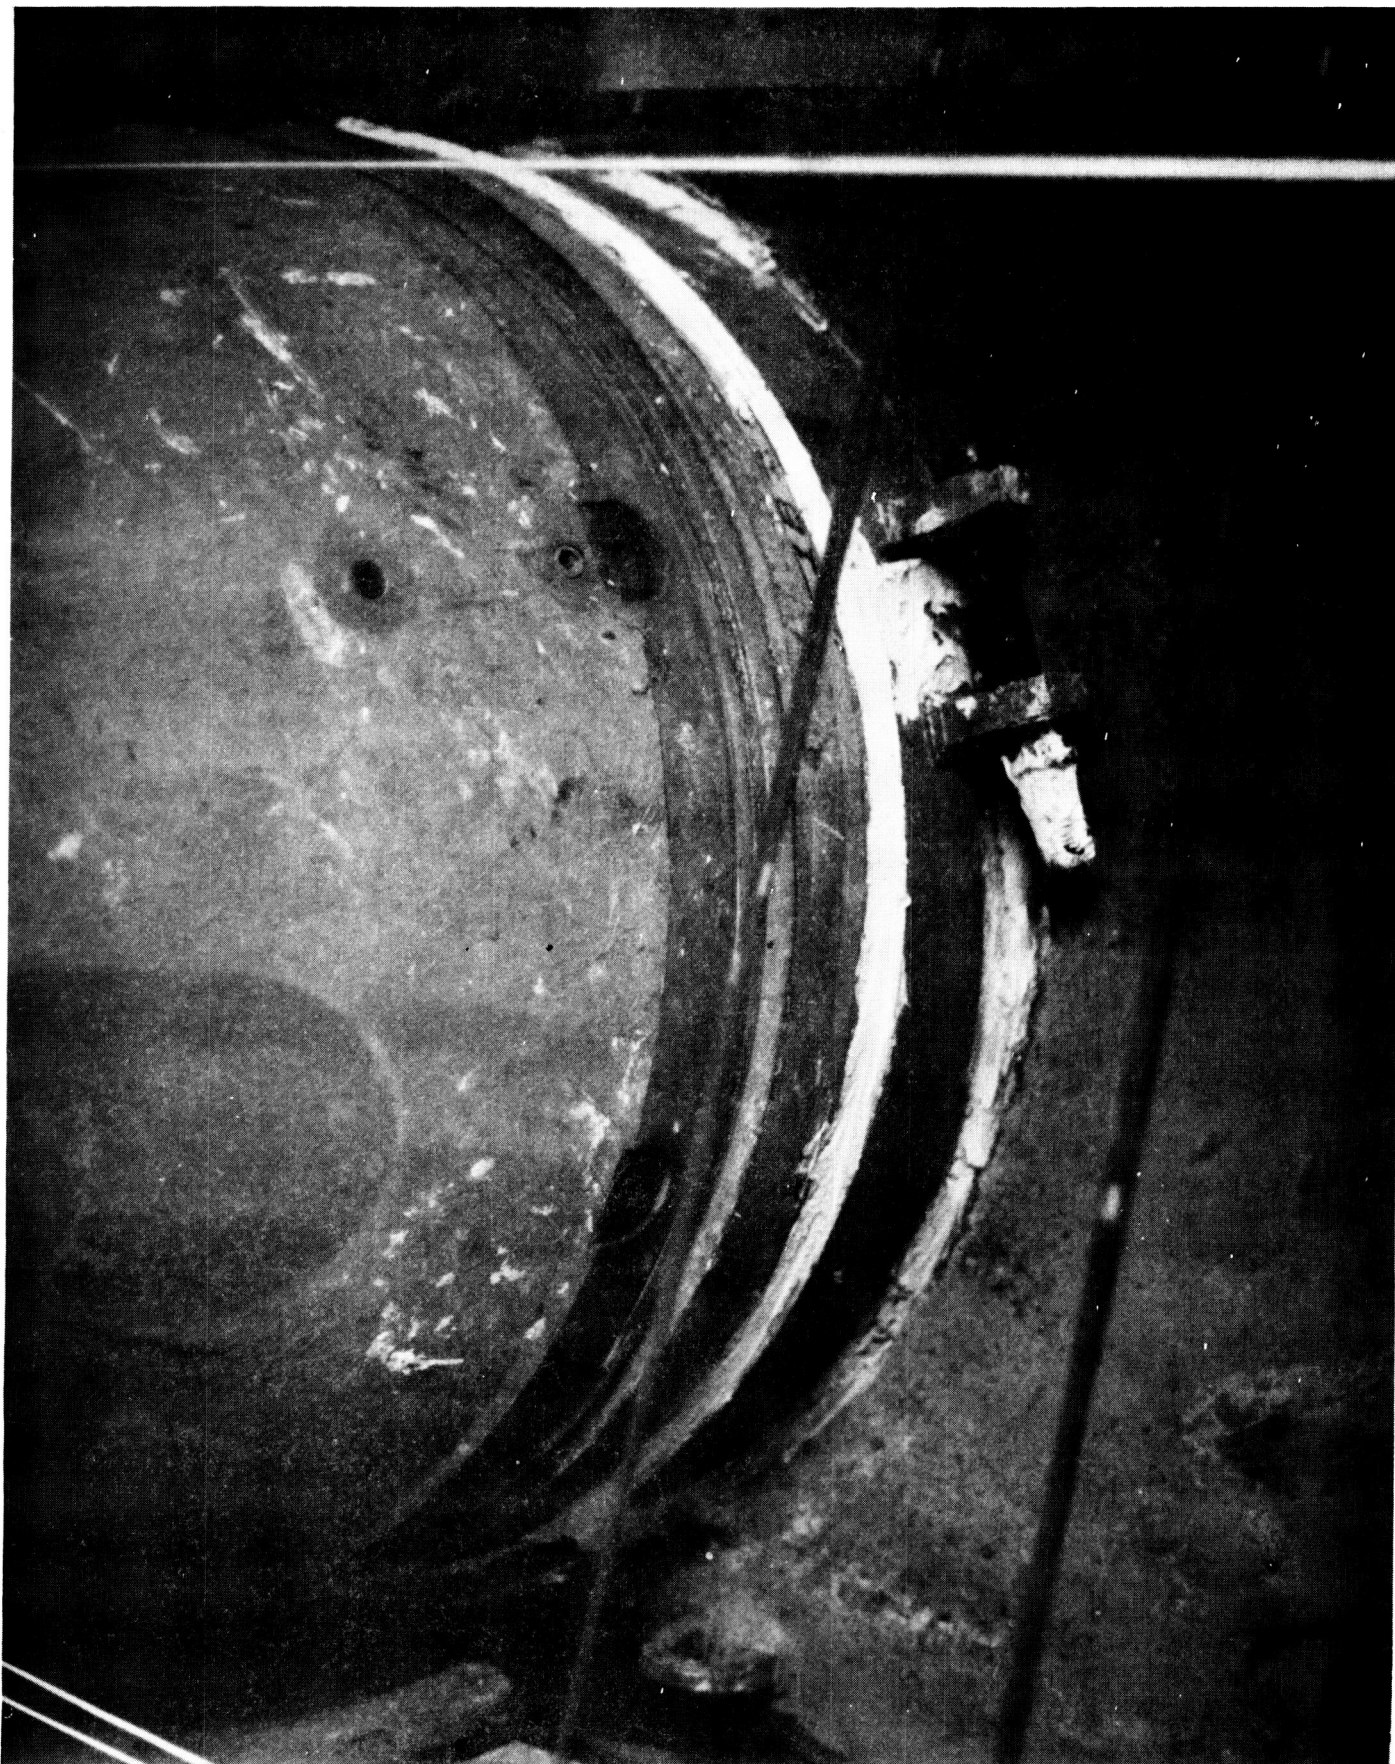
EXCESSIVE RTV ON HOLDDOWN POST STRAIN GAGE BELLY BAND

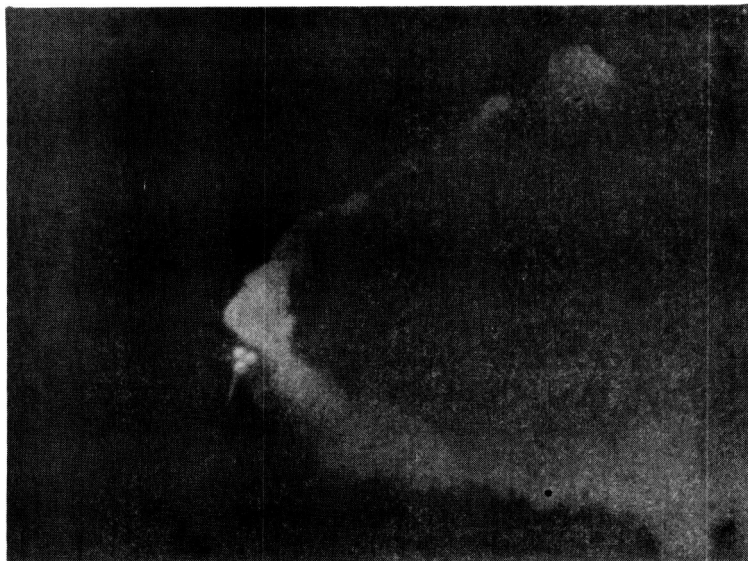
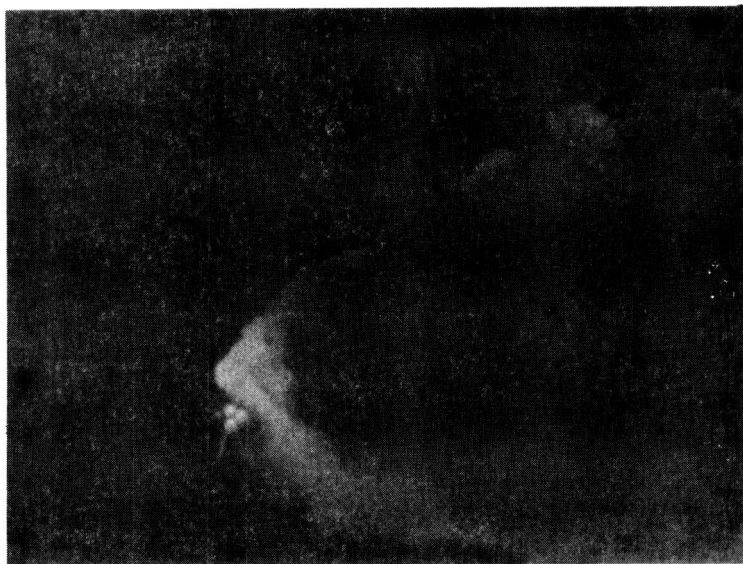
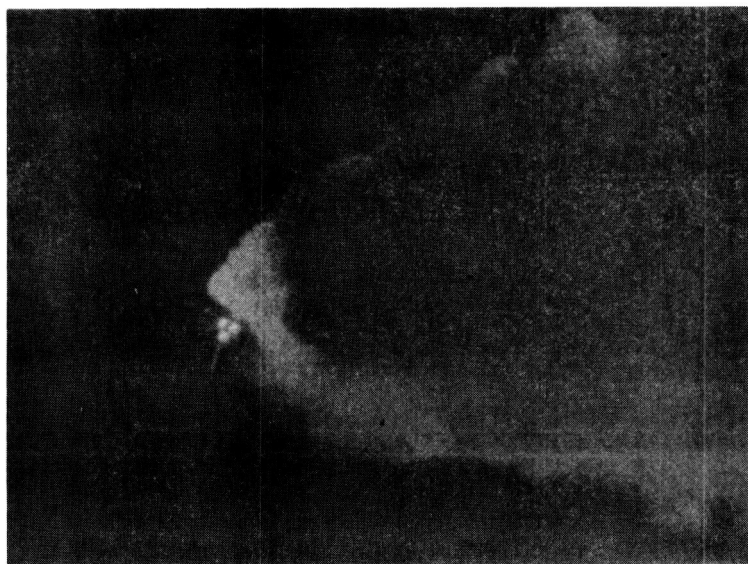
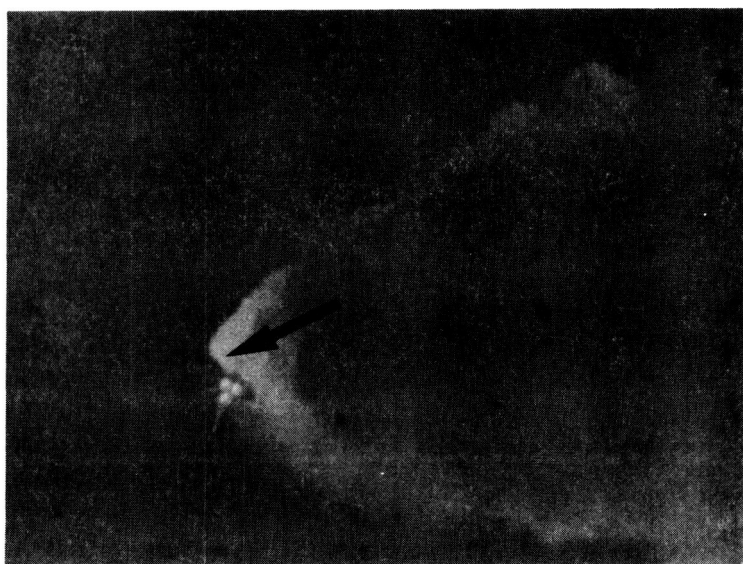
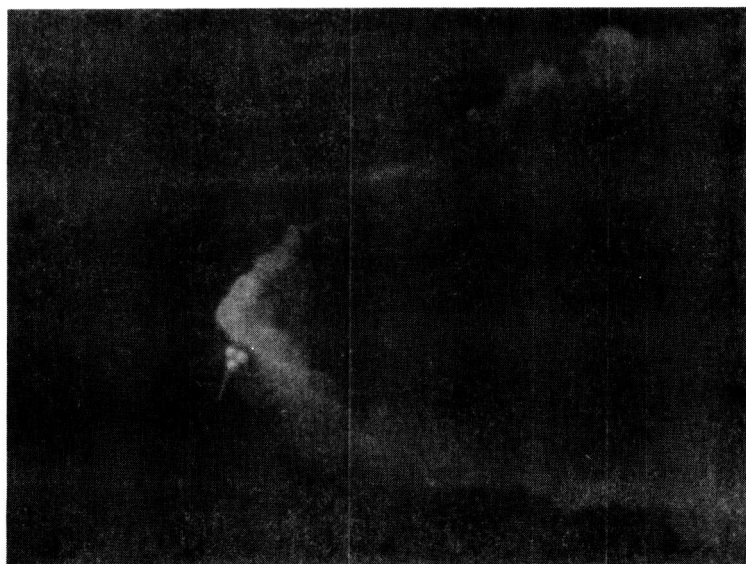
FILM ITEM E-58. SUSPECT RH OMS POD CARRIER PANEL FALLING
FROM VEHICLE AT APPROXIMATELY T+30 SECONDS MET.

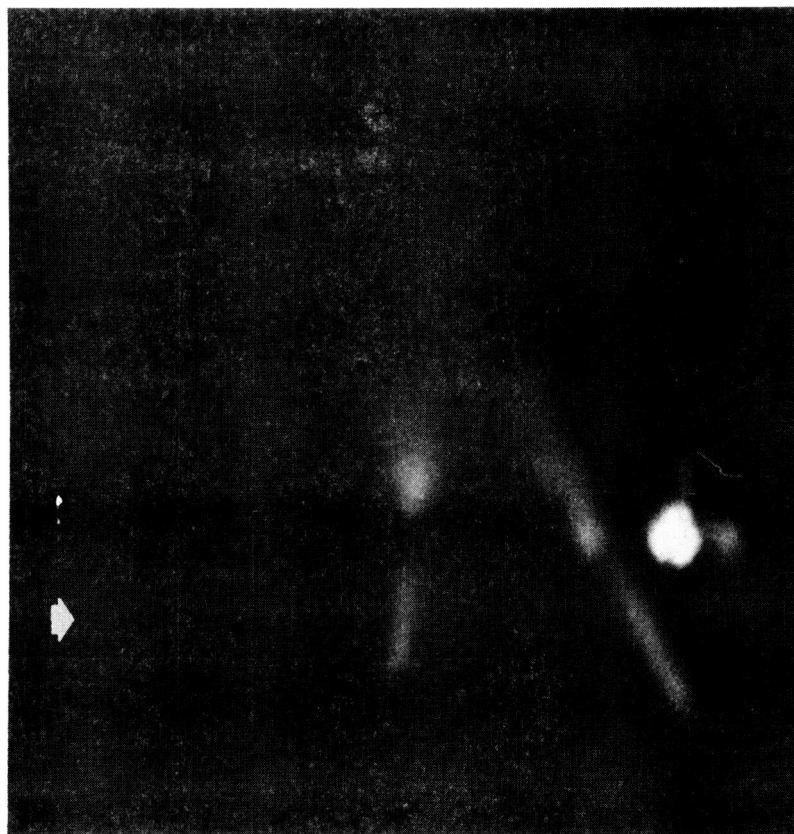
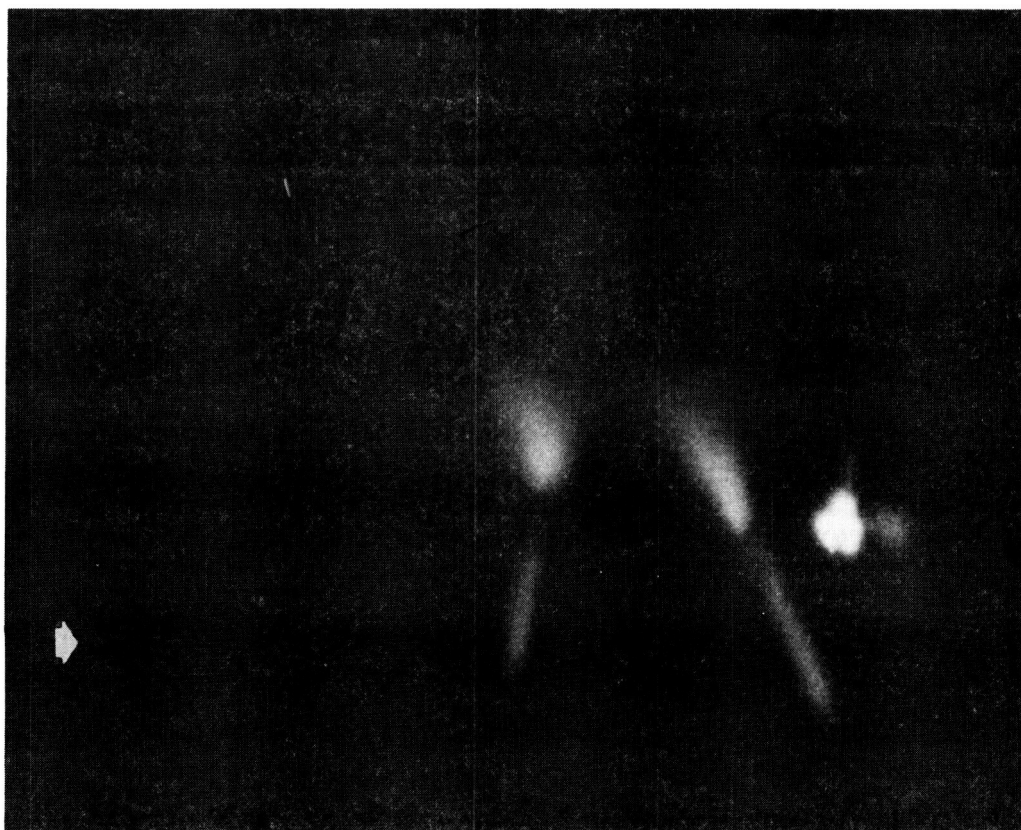
FILM ITEM E-204. REDDISH-COLORED DIFFUSE OBJECT
MOVING AWAY FROM BOOSTERS AT T+129.5 SECONDS MET.

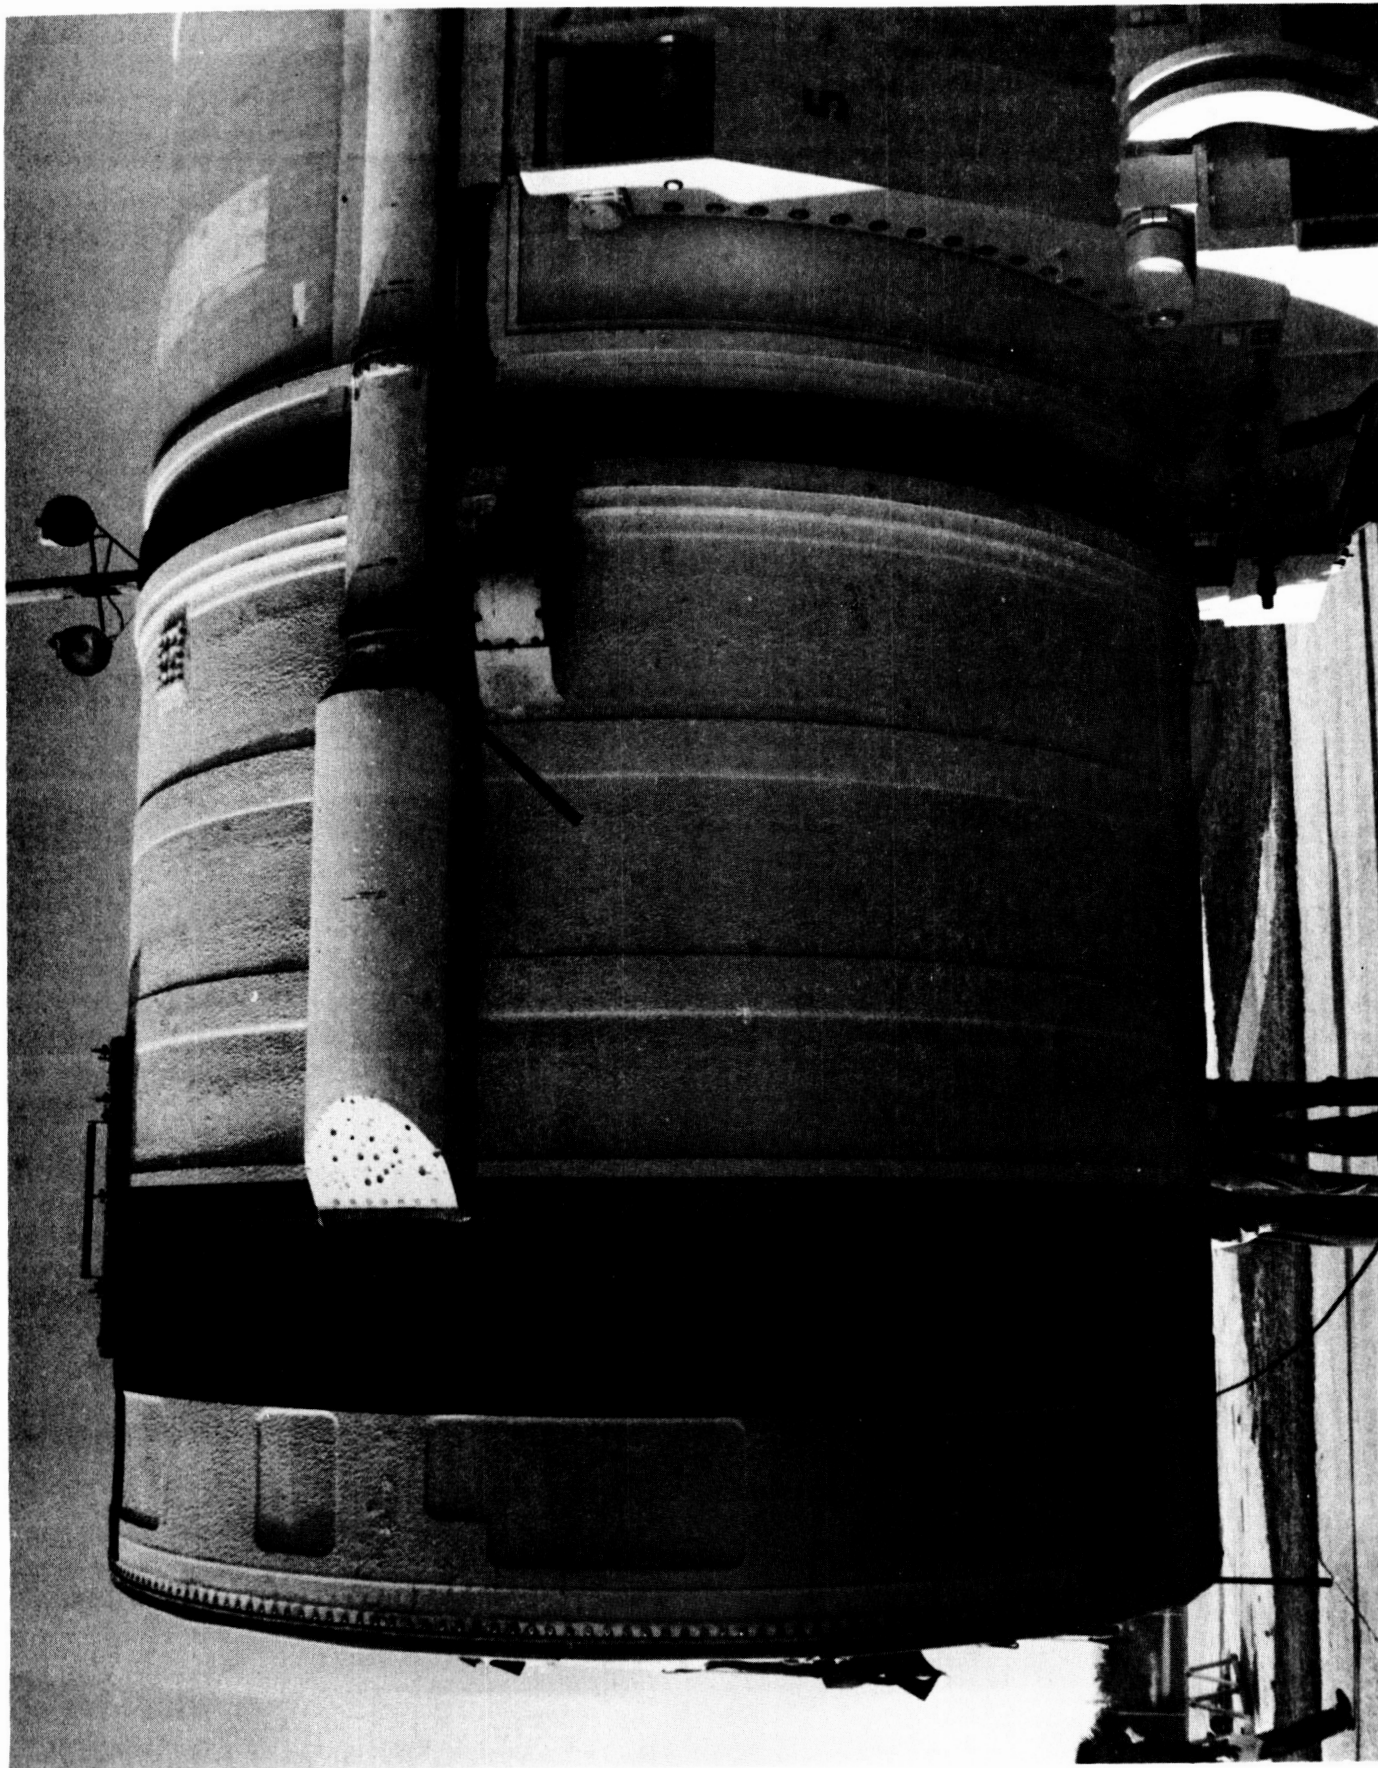
LH SRB FORWARD SKIRT. DFI CLOSEOUT MATERIAL INTACT.
K5NA NOT APPLIED TO SYSTEMS TUNNEL CLOSEOUT.

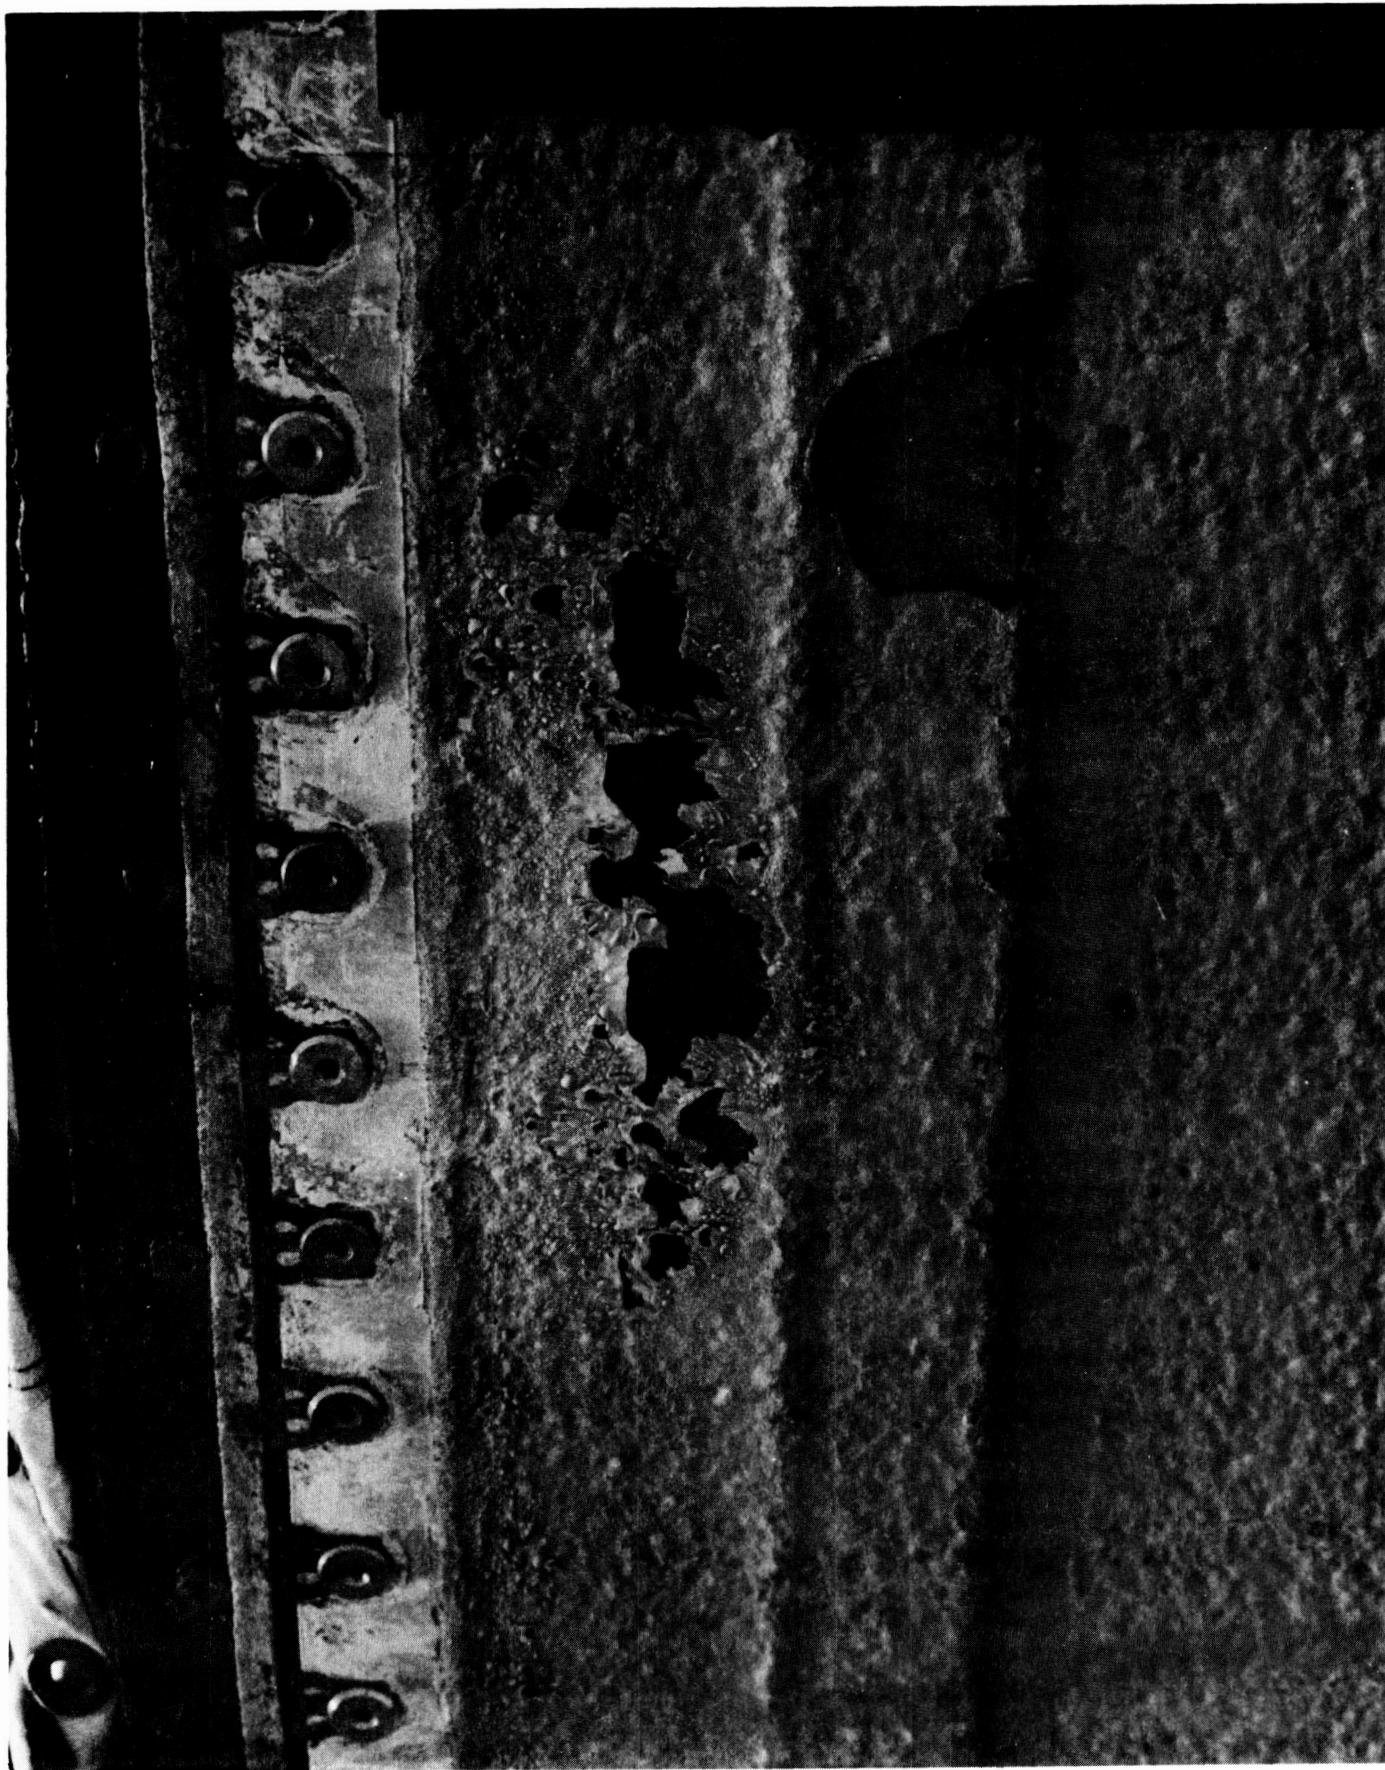
MISSING MSA-1 AND HYPALON PAINT BLISTERING NEAR LINEAR SHAPED
CHARGE. BLISTER CRATERS SHOW SIGNS OF ASCENT AEROHEATING.

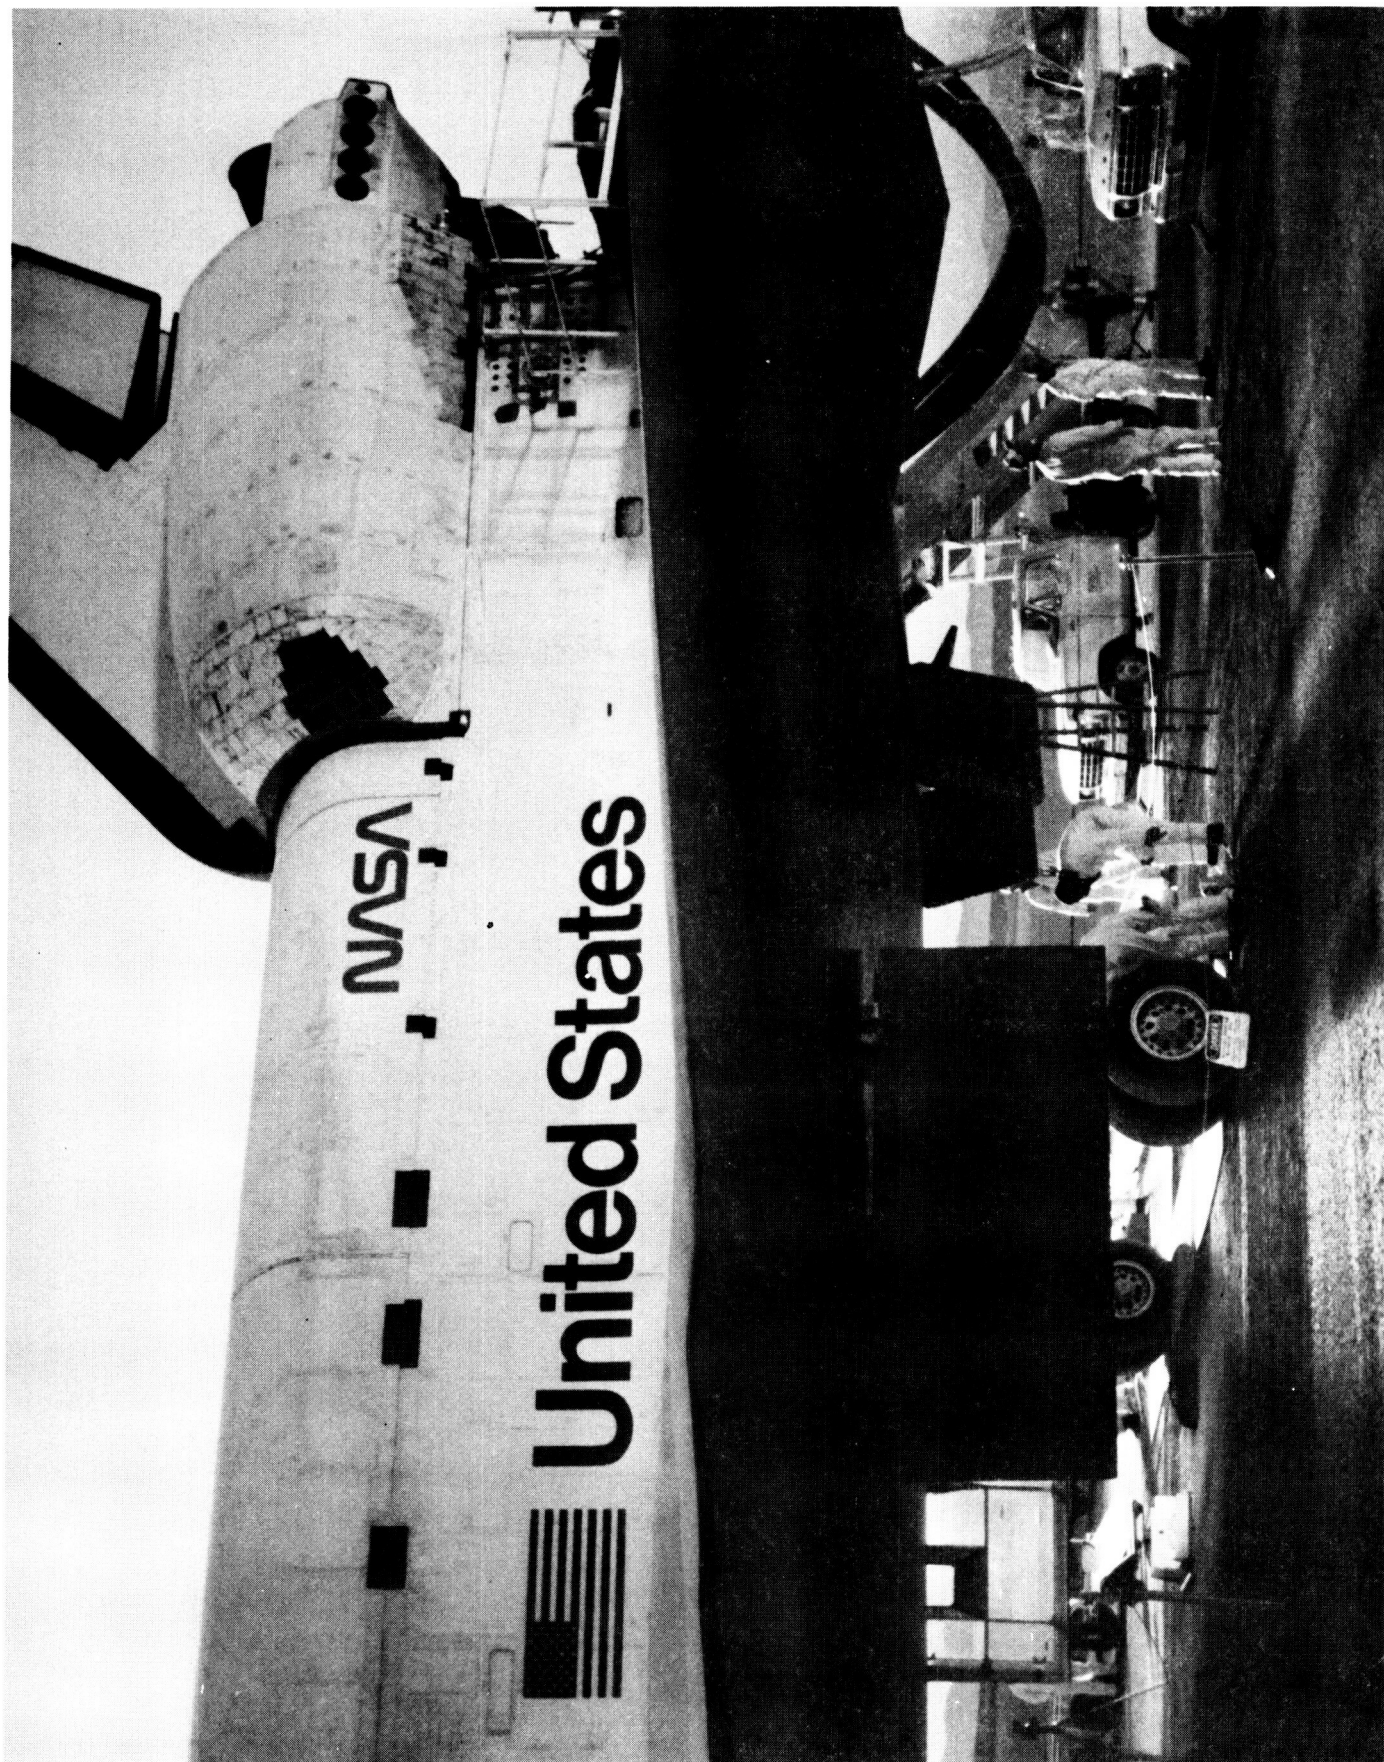
MINIMAL TPS DAMAGE ON LH WING AND ELEVON LOWER SURFACES

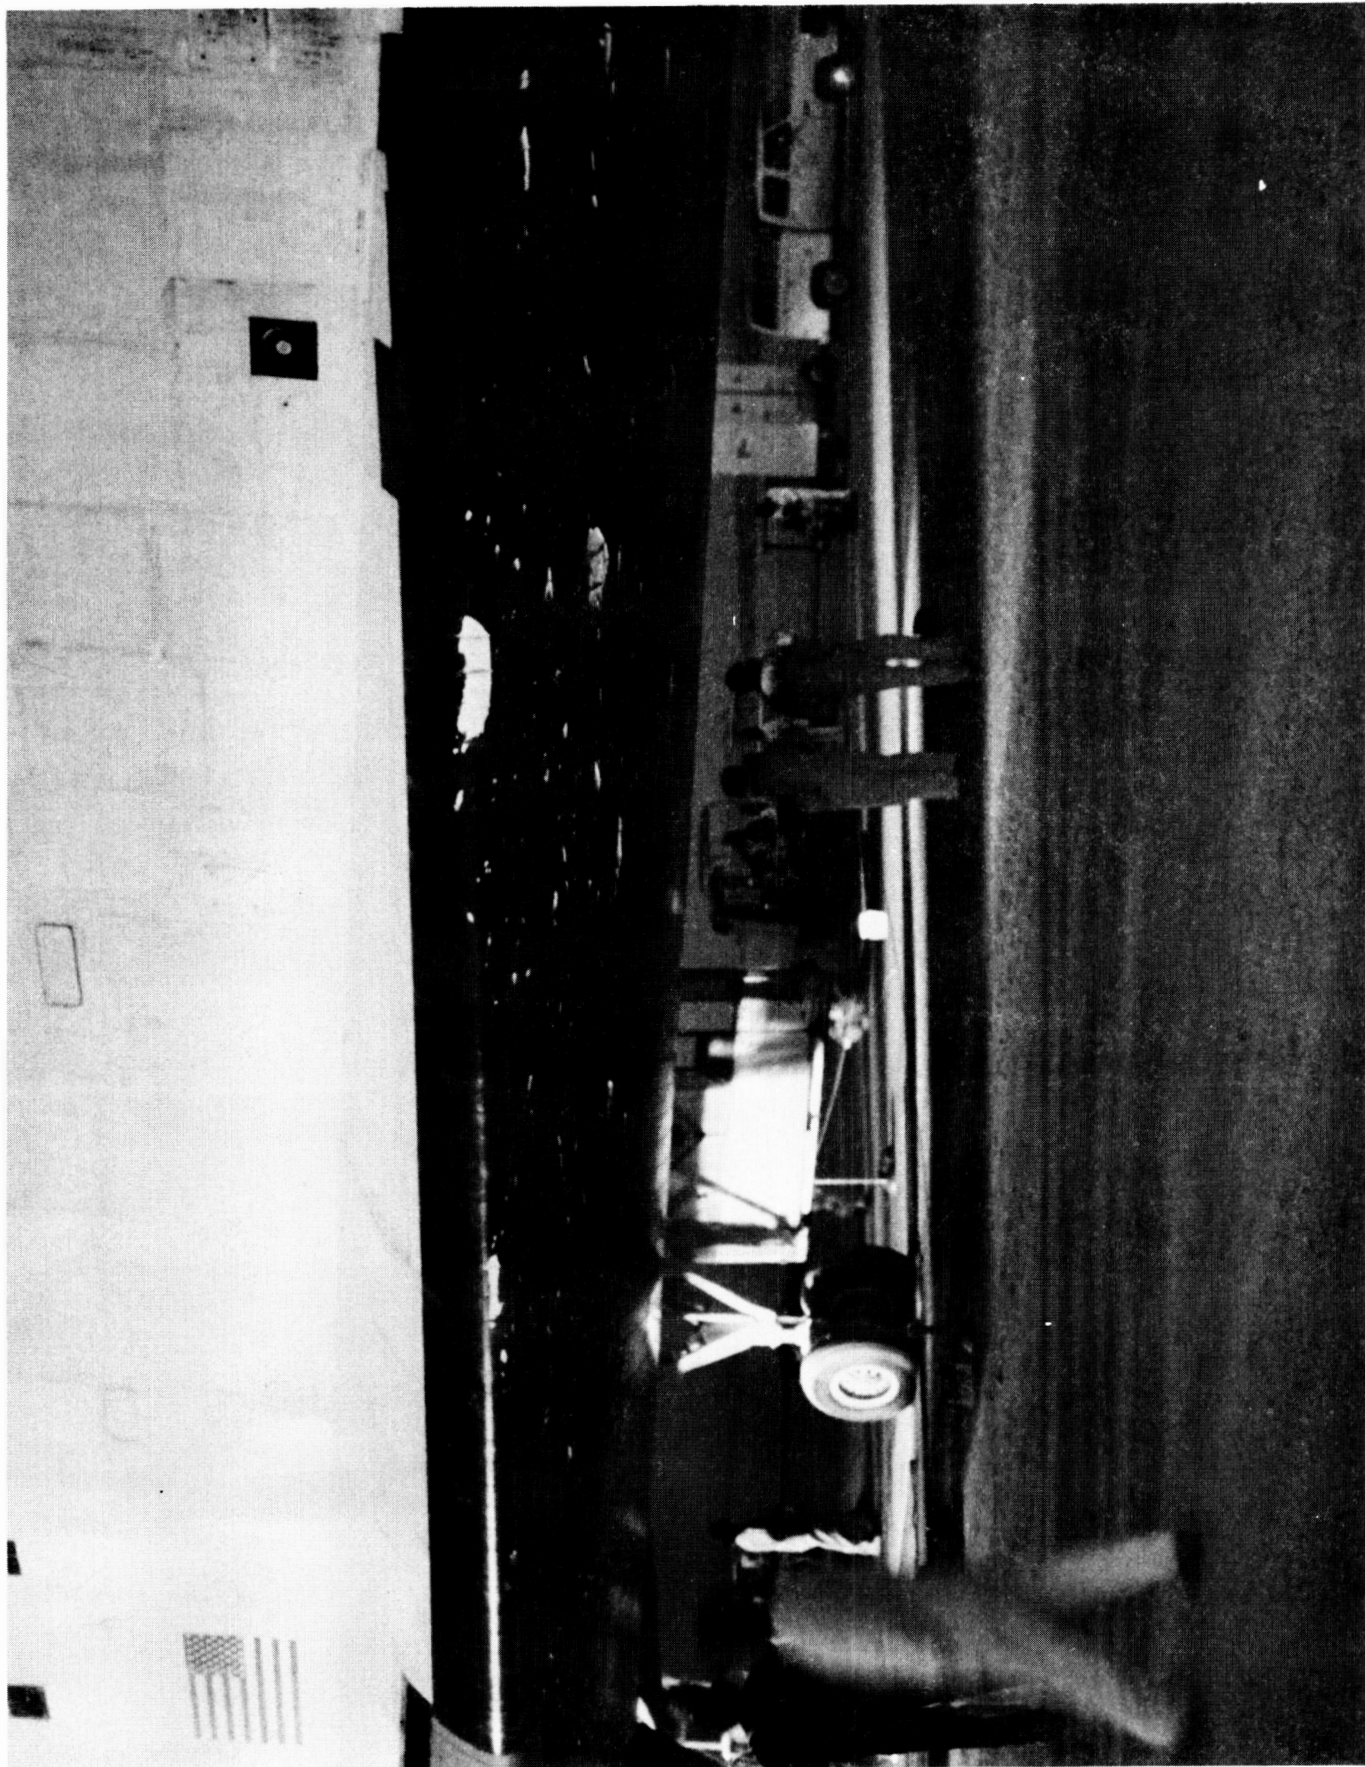
TILE DAMAGE CONCENTRATED ON RH CHINE AND WING LOWER SURFACE

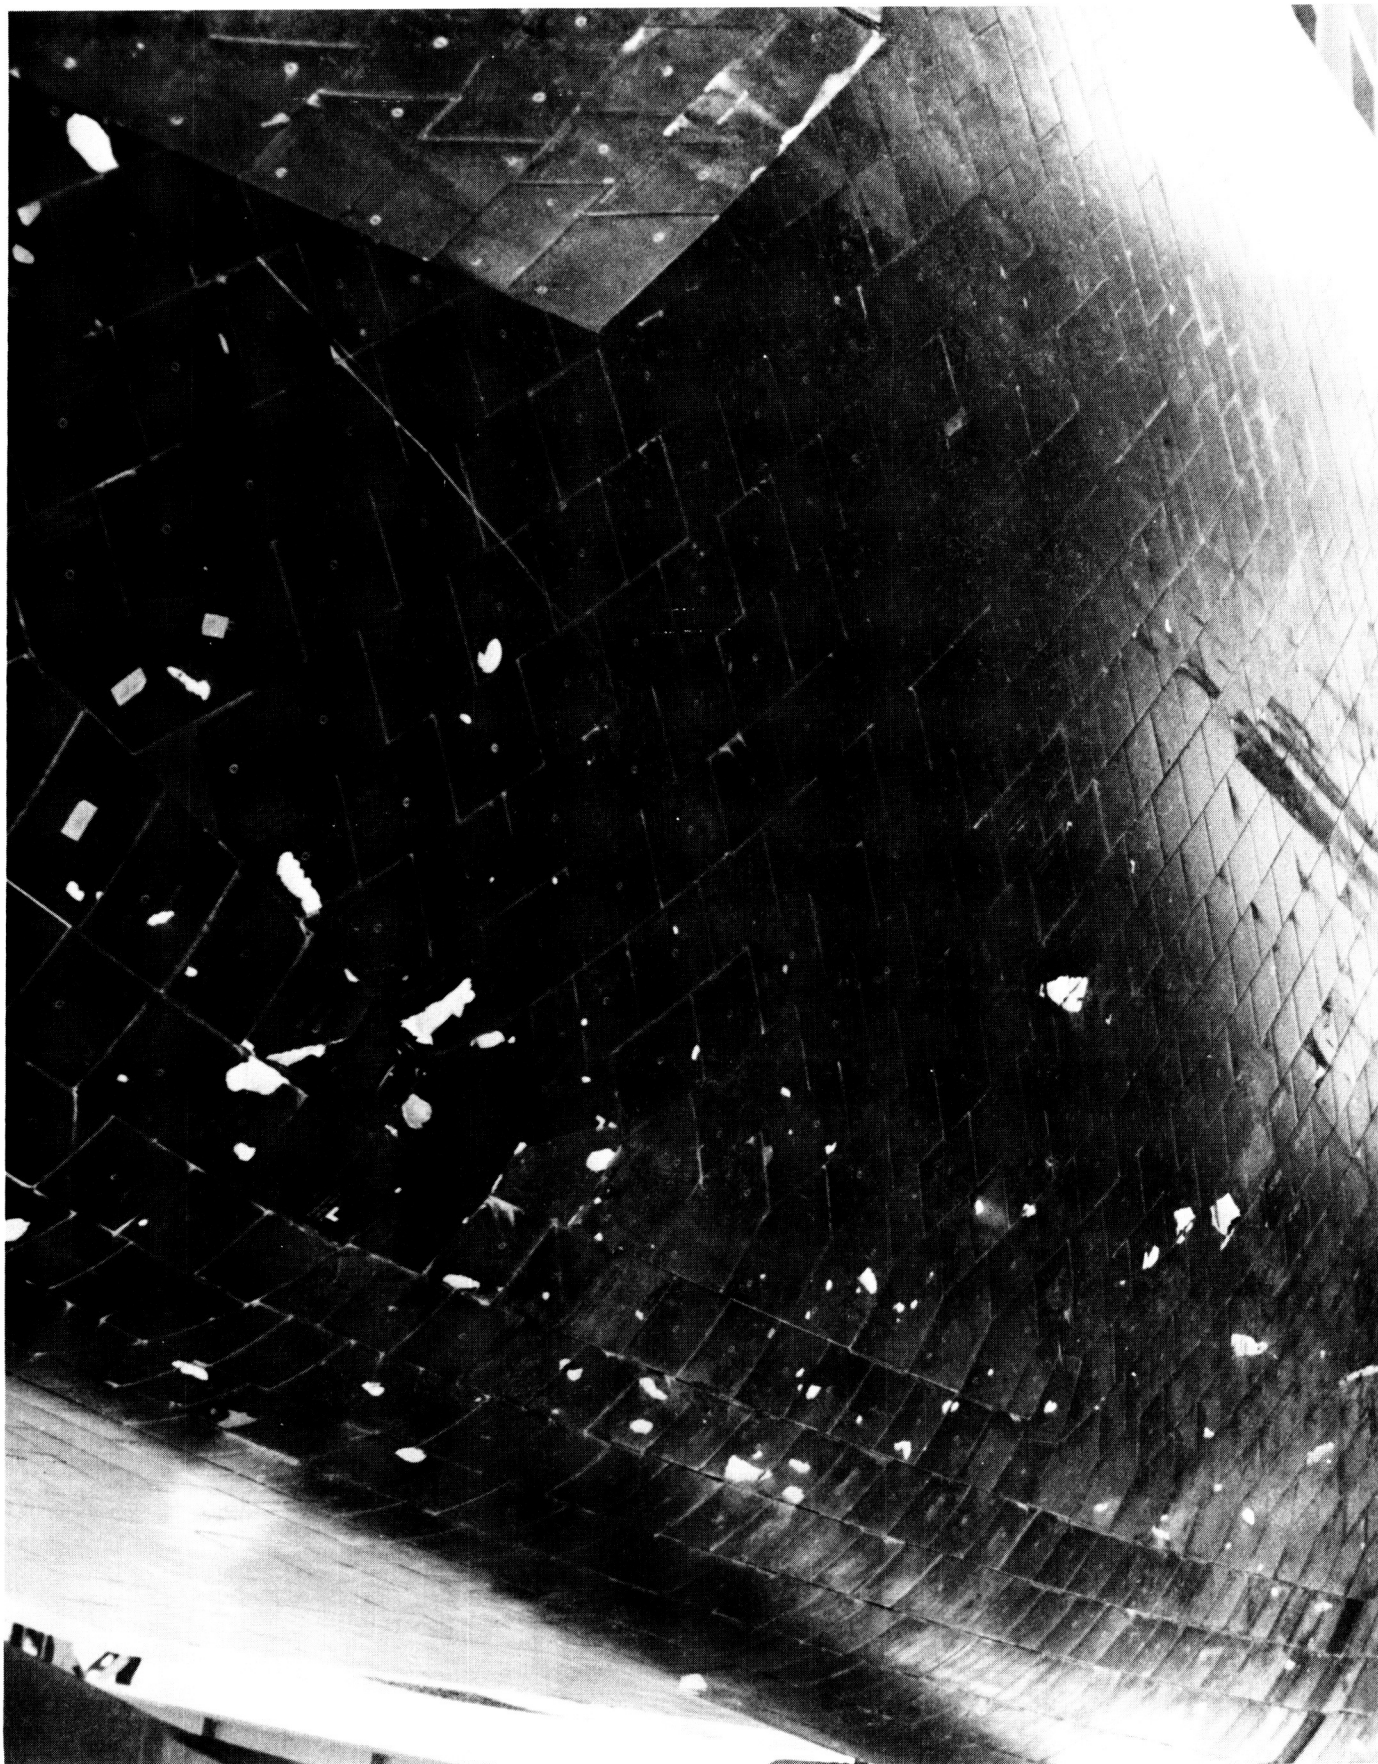
MISSING TILE WAS LOCATED NEAR NOSE LANDING GEAR DOOR
